PHOTOGRAPHIC INTERPRETATION REPORT

RESEARCH AND DEVELOPMENT  
RADAR FACILITY 2  
SARY-SHAGAN ANTIMISSILE TEST CENTER  
USSR

# RESEARCH AND DEVELOPMENT RADAR FACILITY 2 SARY-SHAGAN ANTIMISSILE TEST CENTER, USSR

DECEMBER 1967

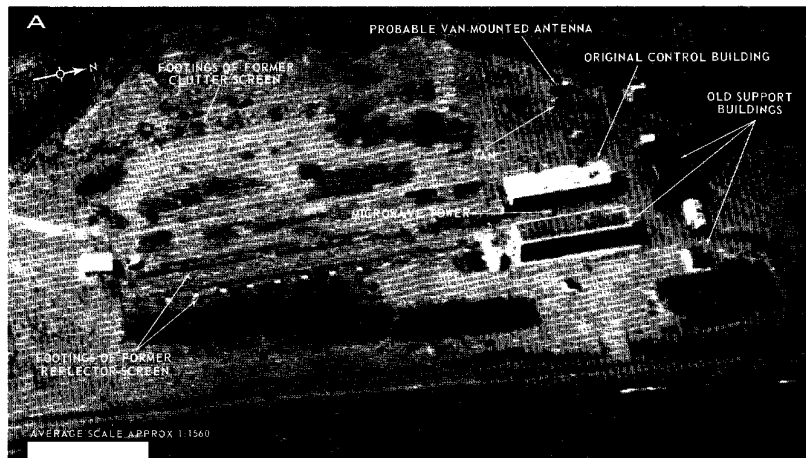
By [redacted] the reflector and clutter screens at HEN ROOST Antenna North had been dismantled, with only the footings remaining. This was the first large-scale coverage of the site since [redacted]

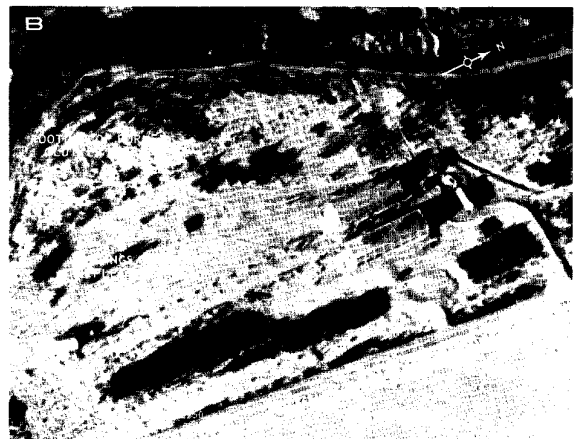
The site was essentially unchanged since [redacted] except for the removal of antenna components and structural members. No evidence is observed of construction of the new antenna structure.

control building. Large-scale coverage of [redacted] (Figure 3B) revealed this area to be essentially unchanged since [redacted] with no evidence of the construction of a screen, as was the case at HEN ROOST Antenna South. Although many crates were removed during that period, some remained at the site. On [redacted] apparent construction activity was noted at the site of the former reflector screen and just west of it. The following mission -- [redacted] -- revealed an A-frame type of construction to be in progress, with the structural supports under construction from south to north, and a probable crane alongside the north portion. By [redacted] one of the 2 small buildings at the south end of the former reflector screen had been removed. Construction continued, with an A-frame structure observed on [redacted] (Figure 3C). Although considerable progress was made between [redacted] the latest and best large-scale coverage of the site (Figures 4 and 5) -- no evidence was yet revealed of an antenna face. The A-frame antenna structure is approximately [redacted] long and has a boresight azimuth of approximately [redacted] degrees. It is supported from the east by 13 main structural supports -- the 9 to the south having a height of [redacted] the second and third from the north a height of [redacted]. The northernmost and fourth from the north appear to fall somewhere between these 2 heights. All 12 sections comprising the structure appear to date to consist of an intricate pattern of heavily trussed horizontal and vertical members in varying degrees of preliminary construction except for the third section from the north where a more advanced stage is observed. Thirteen evenly spaced horizontal members or tiers can be seen here which appear broader, lighter-toned, and have apparently been emplaced on the initial framework of the structure. A tall structure occupies the northernmost section; whether an integral part of the antenna structure or a covered construction elevator cannot be determined. Just west of the antenna structure is a probable assembly jig, presumably used for assembly of the antenna panels. The boresight elevation angle of the A-frame structure is approximately 25 degrees. Spacing between footings is [redacted]. Certain footings of the former reflector screen can be seen in disuse, adjacent to the new supports. Just west of the footings for the former clutter screen numerous crates and possible truss members have appeared since [redacted]. Additional crates have also appeared

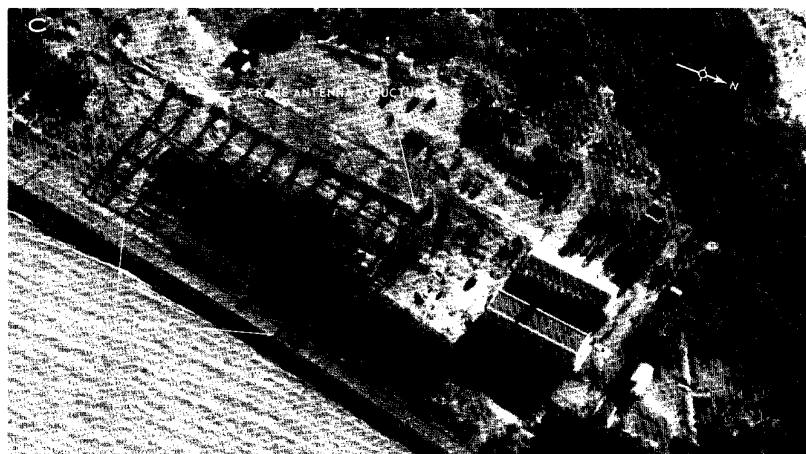
FIGURE 3. ANTENNA NORTH, R&D RADAR FACILITY 2, SSATC.

This is the first large-scale coverage of the new antenna structure under erection and observed for the first time on [redacted]. Note that the northern supports are higher than the southern.

west of the A-frame antenna structure. A crane and 2 power shovels are observed in the area. Since [redacted] new trenching is noted just inside and paralleling the south fence line and the second small structure has been removed at the south end of the A-frame antenna structure.

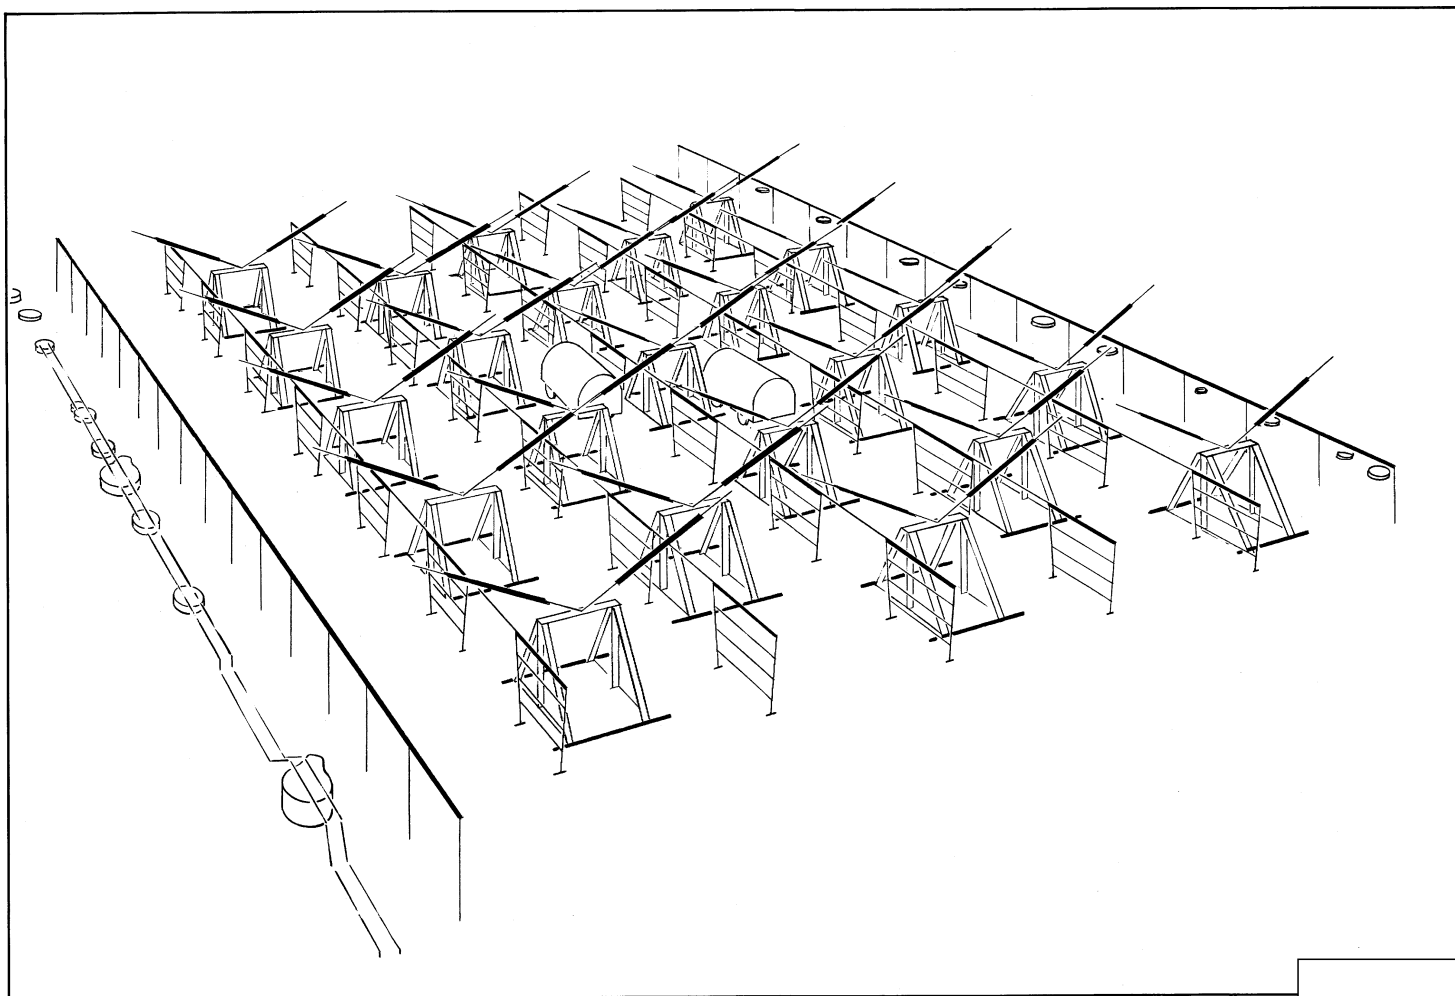
FIGURE 11. PERSPECTIVE CONCEPT OF SUSPECT ANTENNA ARRAY UNDER CONSTRUCTION, R&D RADAR FACILITY 2, SSATC.

Just west of the Probable Electronics Area is a suspect antenna array under construction (Figures 10 and 11). Grading was first observed at the site in [redacted]. This suspect antenna consists of crossed over and under arrays. The lower array, approximately [redacted] above the ground, appears to consist of 5 horizontal linear elements, each approximately 180 feet long and each supported by 7 equally spaced support towers. Although the lower array would appear to serve as a reflector, the possibility of their being active elements cannot be ruled out. The higher array is composed of what appears to be 23 shallow V-shaped elements (approximately [redacted] from tip to tip) mounted in upright positions on individual supports which are approximately [redacted] from the ground. These elements are arranged perpendicularly to the elements in the lower array. One element is currently under assembly. The 2 end portions of each leg of the V-shaped element appear to be thinner than the central portion, which is of bulky configuration. The tips of each leg appear to be approximately [redacted] feet from the ground. The elements of the high array occupy an area approximately 180 feet in length, thus resulting in an area approximately 180 feet square occupied by the low and high array. A narrow, light-toned, horizontal structure, elevated about [redacted] from the ground, generally parallels the linear elements comprising the lower array and is situated on each side of the suspect antenna. Both structures are [redacted] long but appear to be slightly offset and not truly parallel to each other. The approximate separation distance of the 2 western termini is [redacted], of the 2 eastern termini [redacted]. There are indications of a possible cable arrangement parallel to and about [redacted] outside of each structure. Two probable vans [redacted] are at the center of the suspect array and a truck-mounted crane and construction materials are present along its perimeter. Just to the southeast of the suspect antenna is a possible element assembly/test area containing 1 element assembled.
